**INSTALLATION RESTORATION PROGRAM (IRP)  
STAGE 3**

**McCLELLAN AIR FORCE BASE**

**OPERABLE UNIT B  
PRELIMINARY ASSESSMENT  
SUMMARY REPORT**

**VOLUME I: TEXT, APPENDIX A,  
& APPENDIX B (Part 1)**

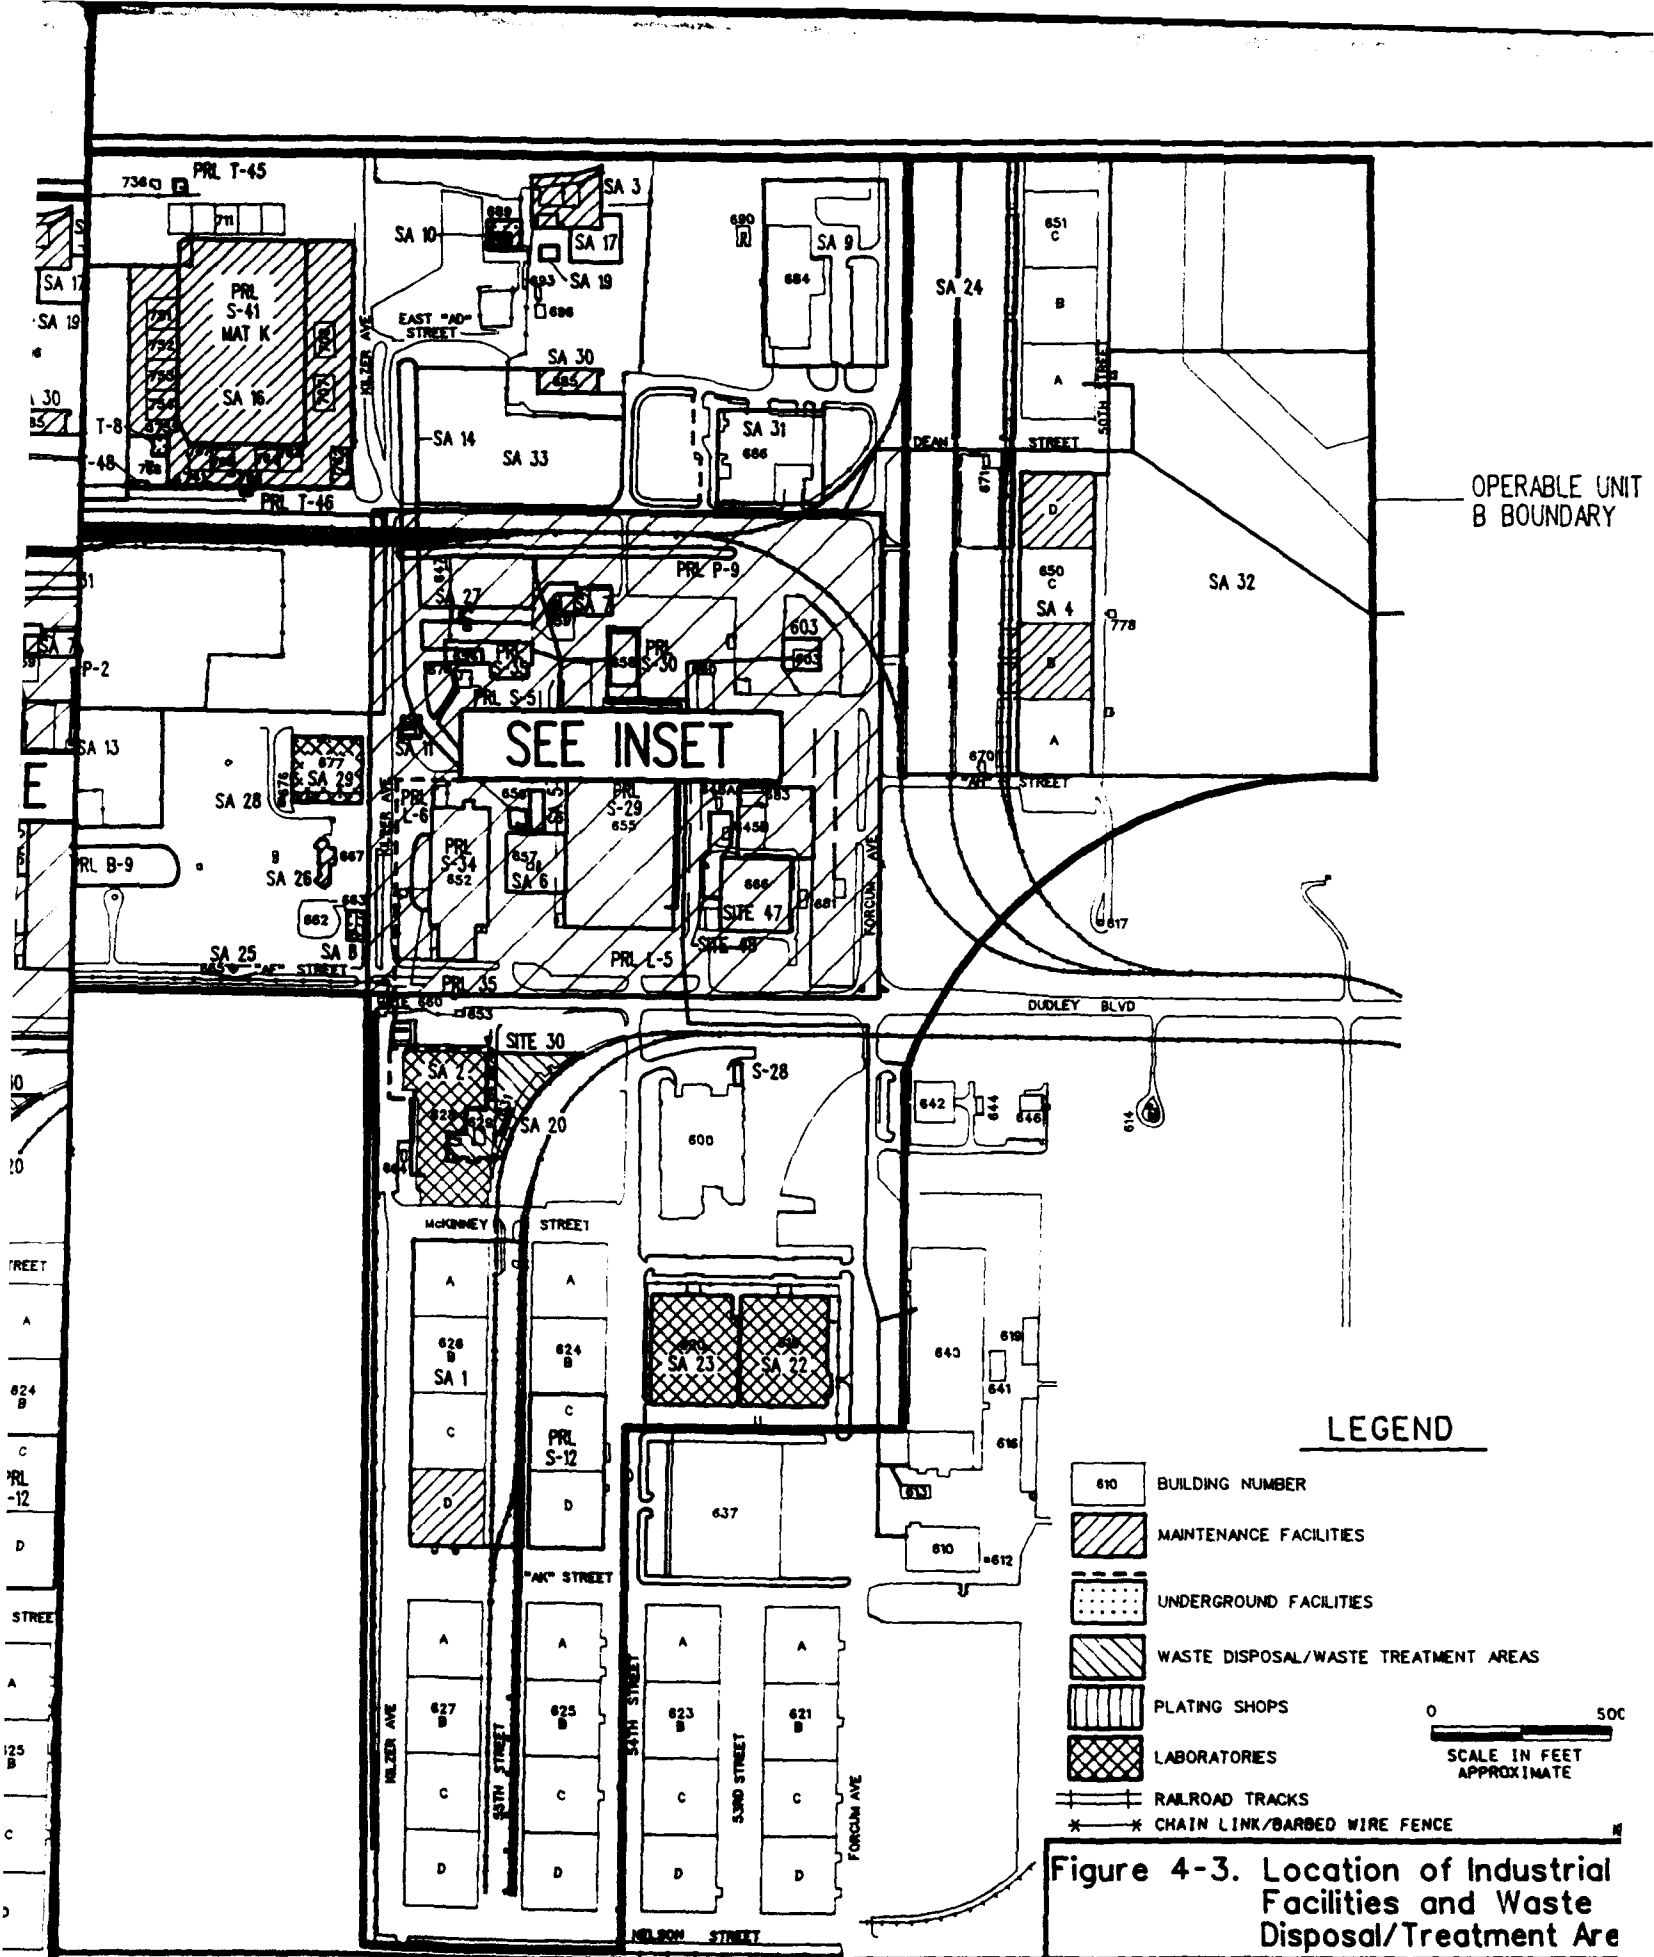
Figure 4-3. Location of Industrial Facilities and Waste Disposal/Treatment Area

The underground facilities include the Industrial Wastewater Line (IWL) that runs through the central portion of OU B and the underground storage tanks located throughout OU B (Figure 4-3). The portion of the IWL delineated as PRL L-6 historically collected laboratory wastewater from Building 628; this portion of the IWL line is no longer used because Building 628 is being decommissioned. The portion of the IWL delineated as PRL L-5 collects wastewater from 10 buildings located near Building 655. In 1988, EG&G Idaho, Inc. leak-tested portions of the IWL in OU B and found a number of leaks. As a result of those findings, PRL L-5 and PRL L-6 were added to the Site-PRL list. Most of the leaks found in the operating IWL at PRL L-5 have been repaired. To date, leaks in PRL L-6 have not been repaired.

The location of the plating shop (Building 666) and the laboratories (Buildings 618, 620, 628, and 677) in OU B are shown in Figure 4-3. Situated in the central portion of OU B, the plating shop operated between 1957 and 1980. The building was dismantled in 1988. The chemistry/radionuclide laboratory in Building 628 was used for research and chemical analysis and generated hazardous materials. Building 677 is an equipment calibration laboratory, and Buildings 618 and 620 are software and electronics laboratories; these three laboratories generate very little or no hazardous waste.

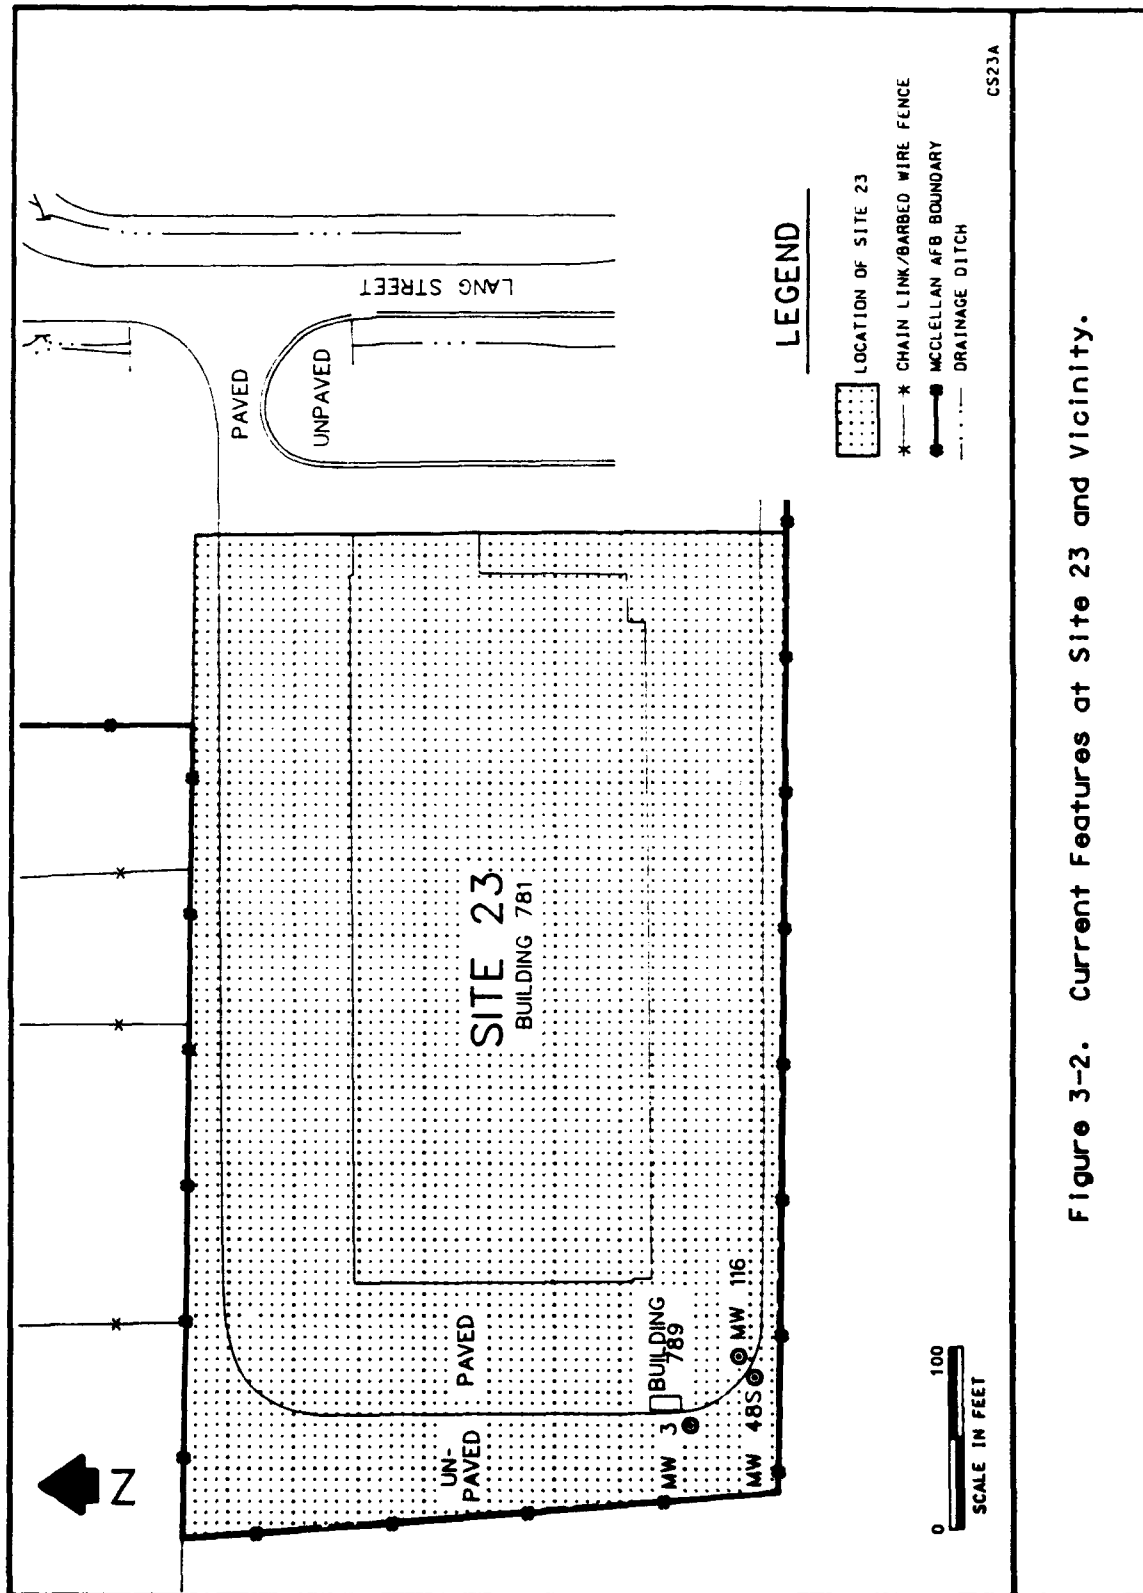
Figure 3-2. Current Features at Site 23 and Vicinity.

The historical aerial photographs reviewed by Radian show evidence of soil disturbance outside of McLaren's original boundaries for Site 23. Radian believes the site boundaries shown in Figure 3-2 more adequately encompass the area of concern.

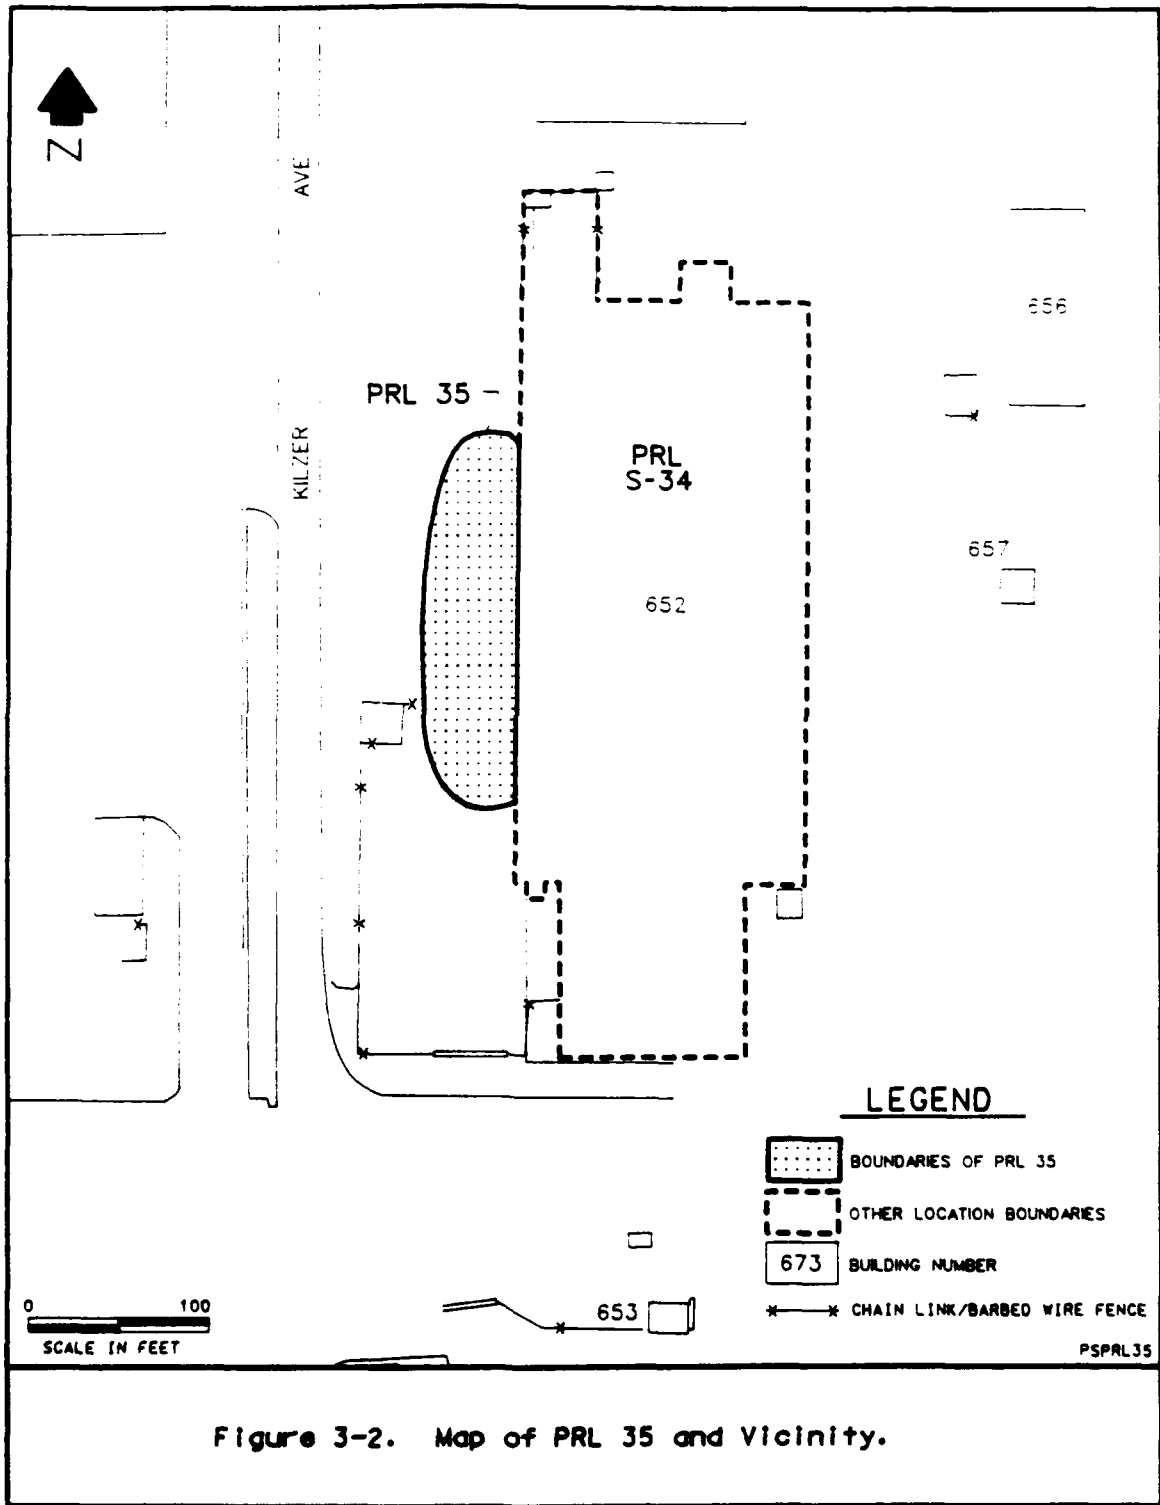
Figure 3-2. Map of PRL 35 and Vicinity.

The aerial photographs Radian reviewed do not show any evidence of an excavation in the area of PRL 35. The only photograph of the area available for the World War II period was taken in 1943. There is no indication of the presence of a burial pit in the 1943 photograph. All of the reviewed photographs taken prior to 1946 show the area as undeveloped land.

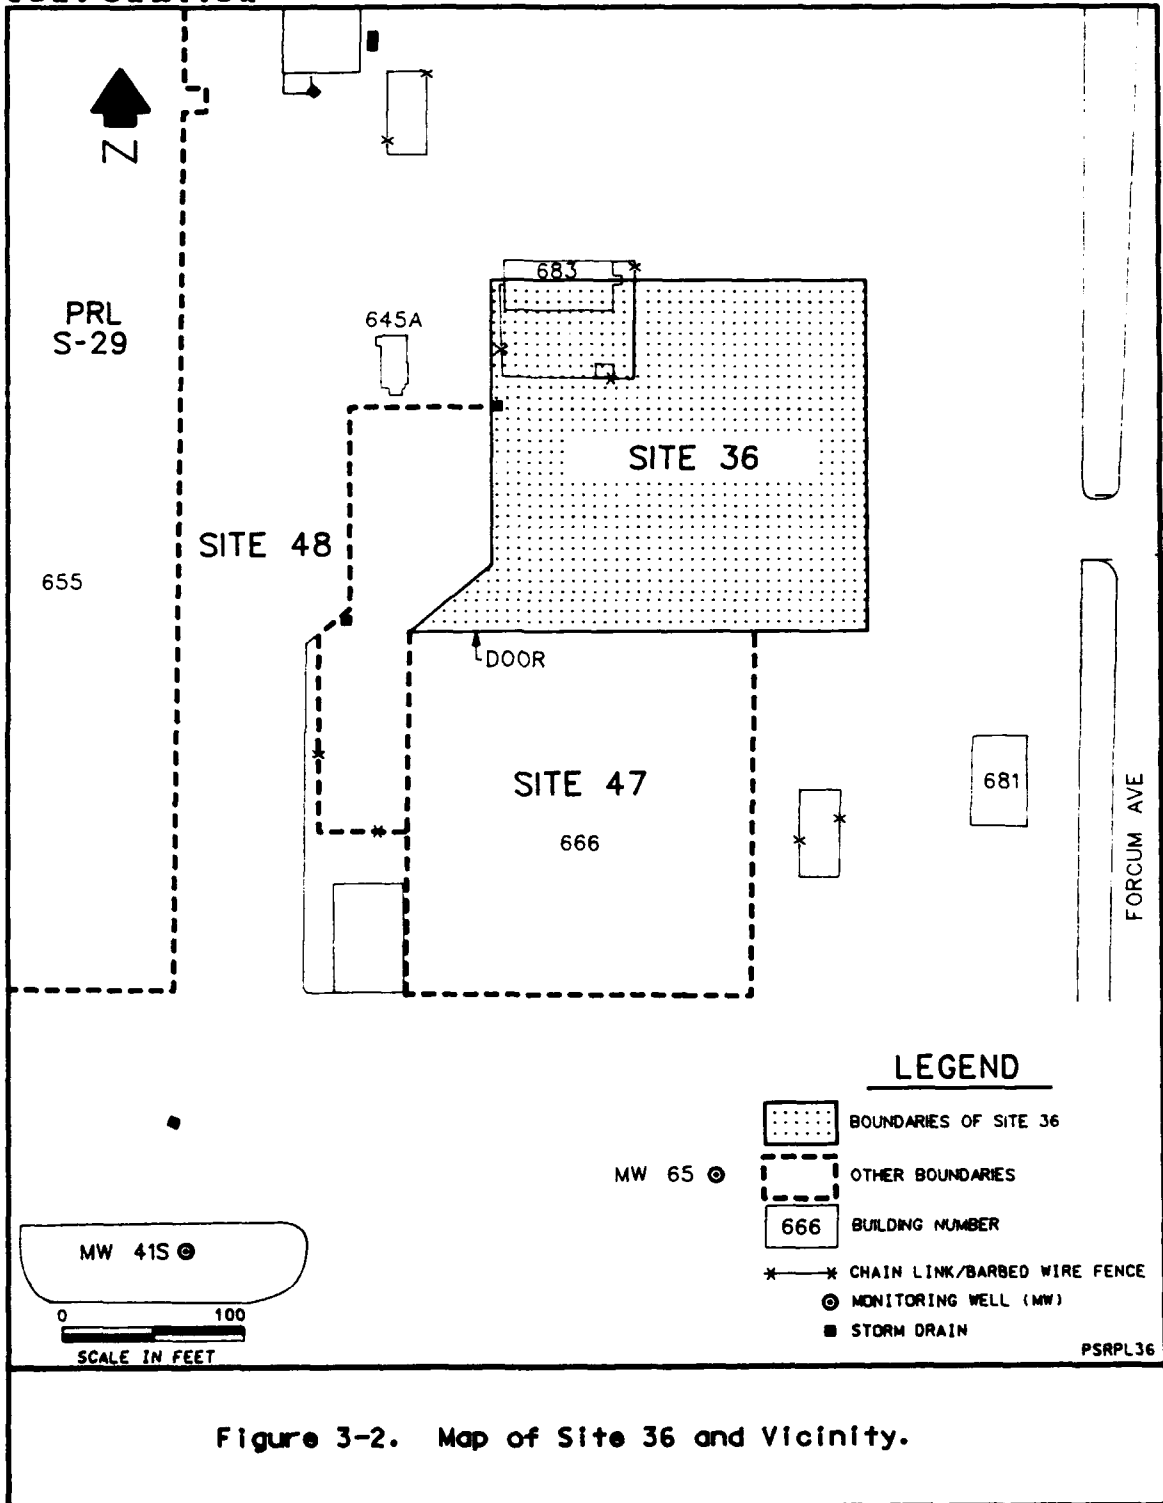
Figure 3-2. Map of Site 36 and Vicinity.

Radian's delineation of the Site 36 boundaries is shown in Figure 3-2. This delineation represents a composite of the most conservative boundaries identified by McLaren. The southern boundary is considered accurate because interviews with base personnel have indicated that plating shop materials were stored directly against Building 666 (Cruz, personal communication, 1989). Less is known about the northern

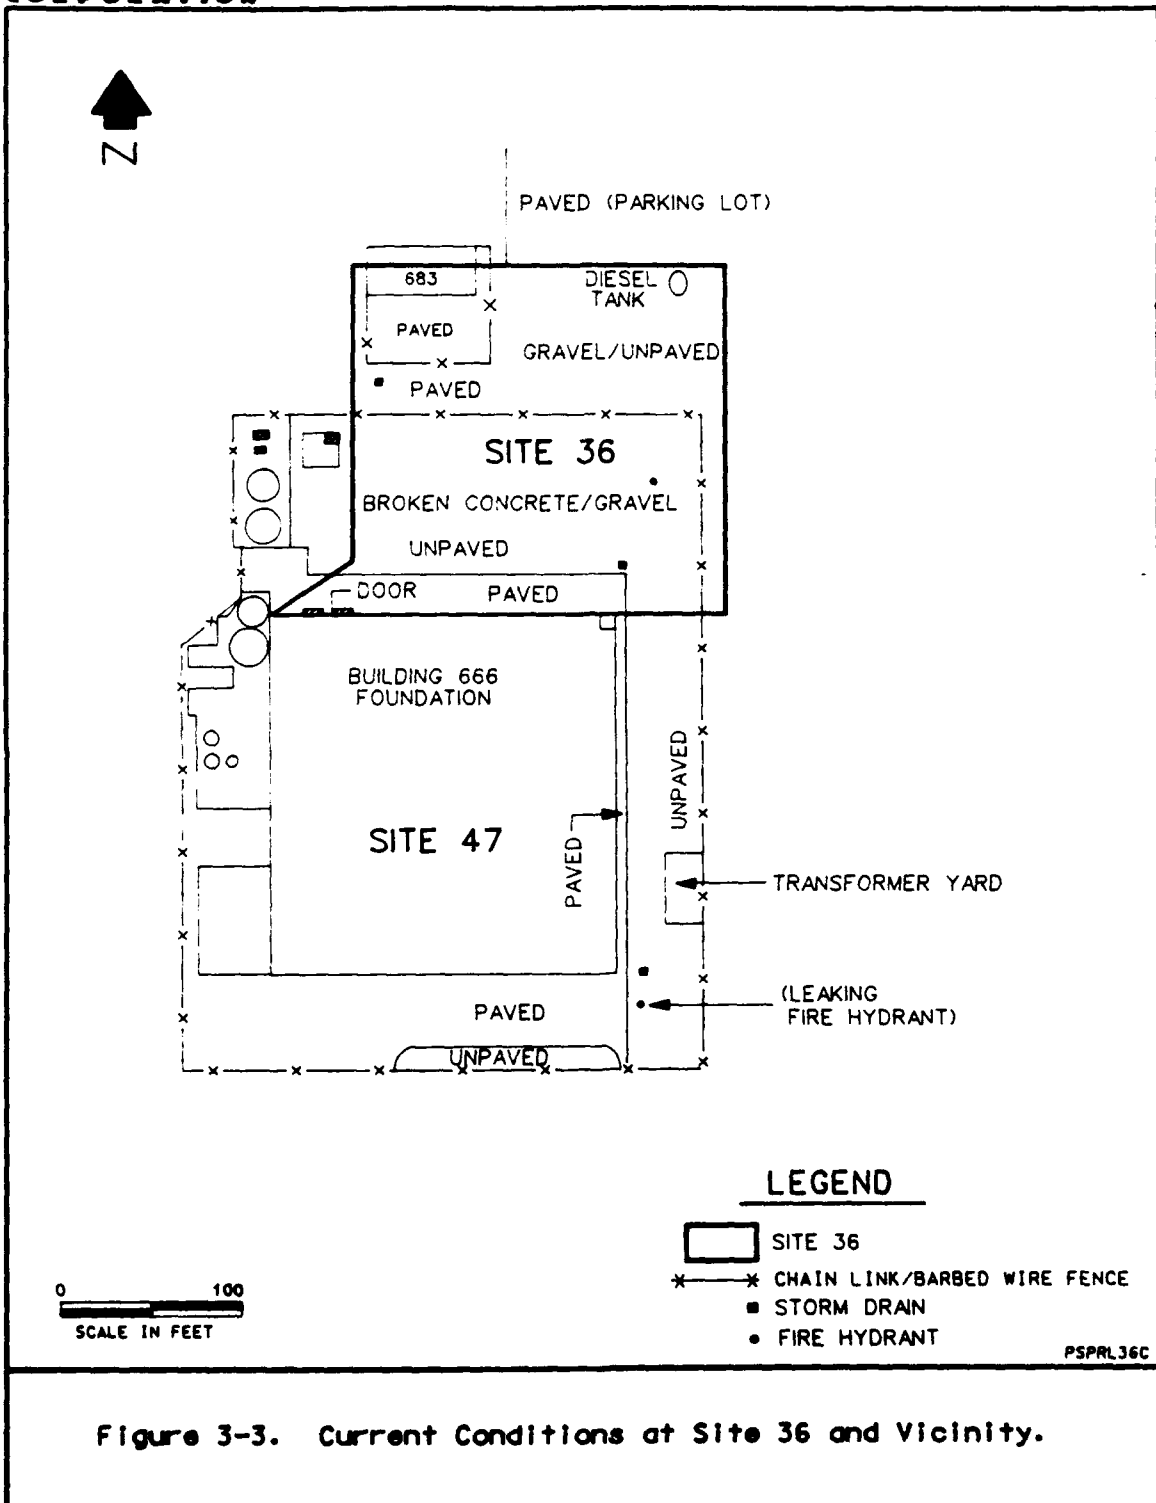
Figure 3-3. Current Conditions at Site 36 and Vicinity.

The surface of Site 36 generally slopes gently to the west. During the site visit, small pools of water were noted on the north and east sides of the site. Two storm drains, which discharge to Arcade Creek, are located at Site 36 (McClellan AFB, 1967). The locations of these features are shown in Figure 3-3.

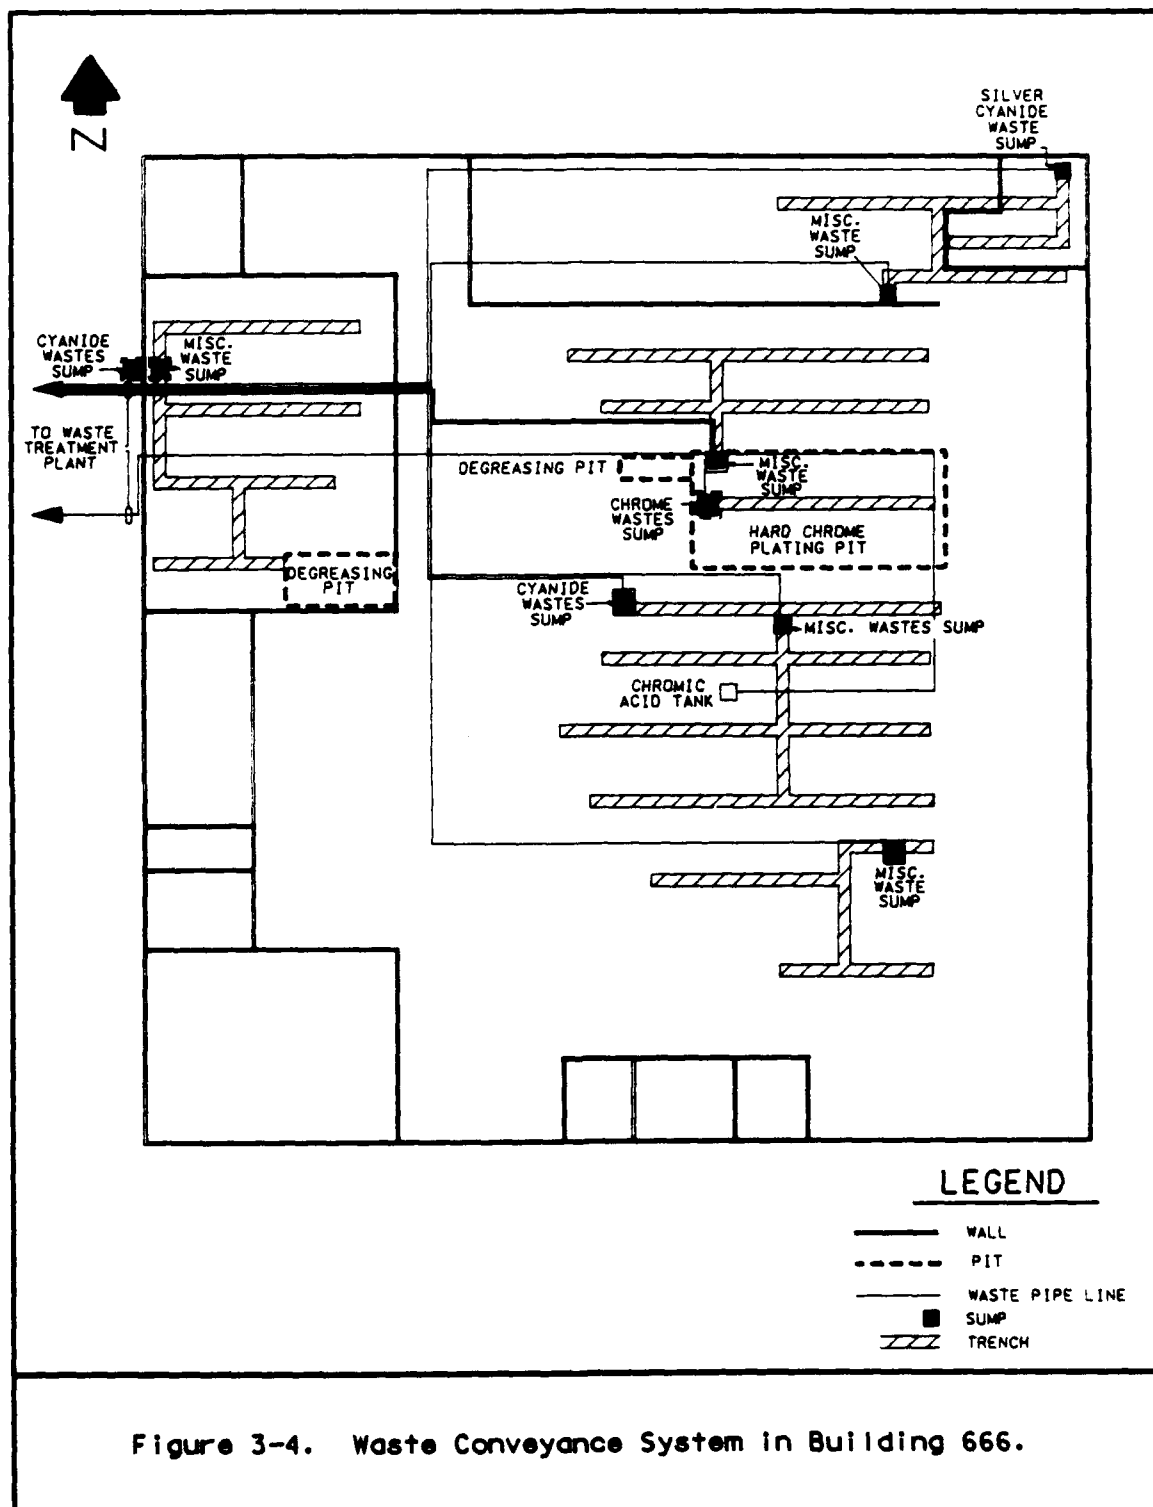
Construction diagrams show the trenches were built with a foundation of reinforced concrete lined with acid-resistant brick and mortar. When the solution in a tank was exhausted, a valve was opened and the solution drained into the trenches (Cruz, personal communication, 1989). After the solution had drained completely, the tank was rinsed with water to remove any remaining sludge. Water applied through high pressure hoses was used to clean the floors near the plating lines; this water also drained into the trenches.

As shown in Figure 3-4, the trenches drained into nine different sumps. Sump pumps transported waste from the bottom of the sumps into wasteline pipes. The pipelines were located underground and discharged into the IWTP No. 4.

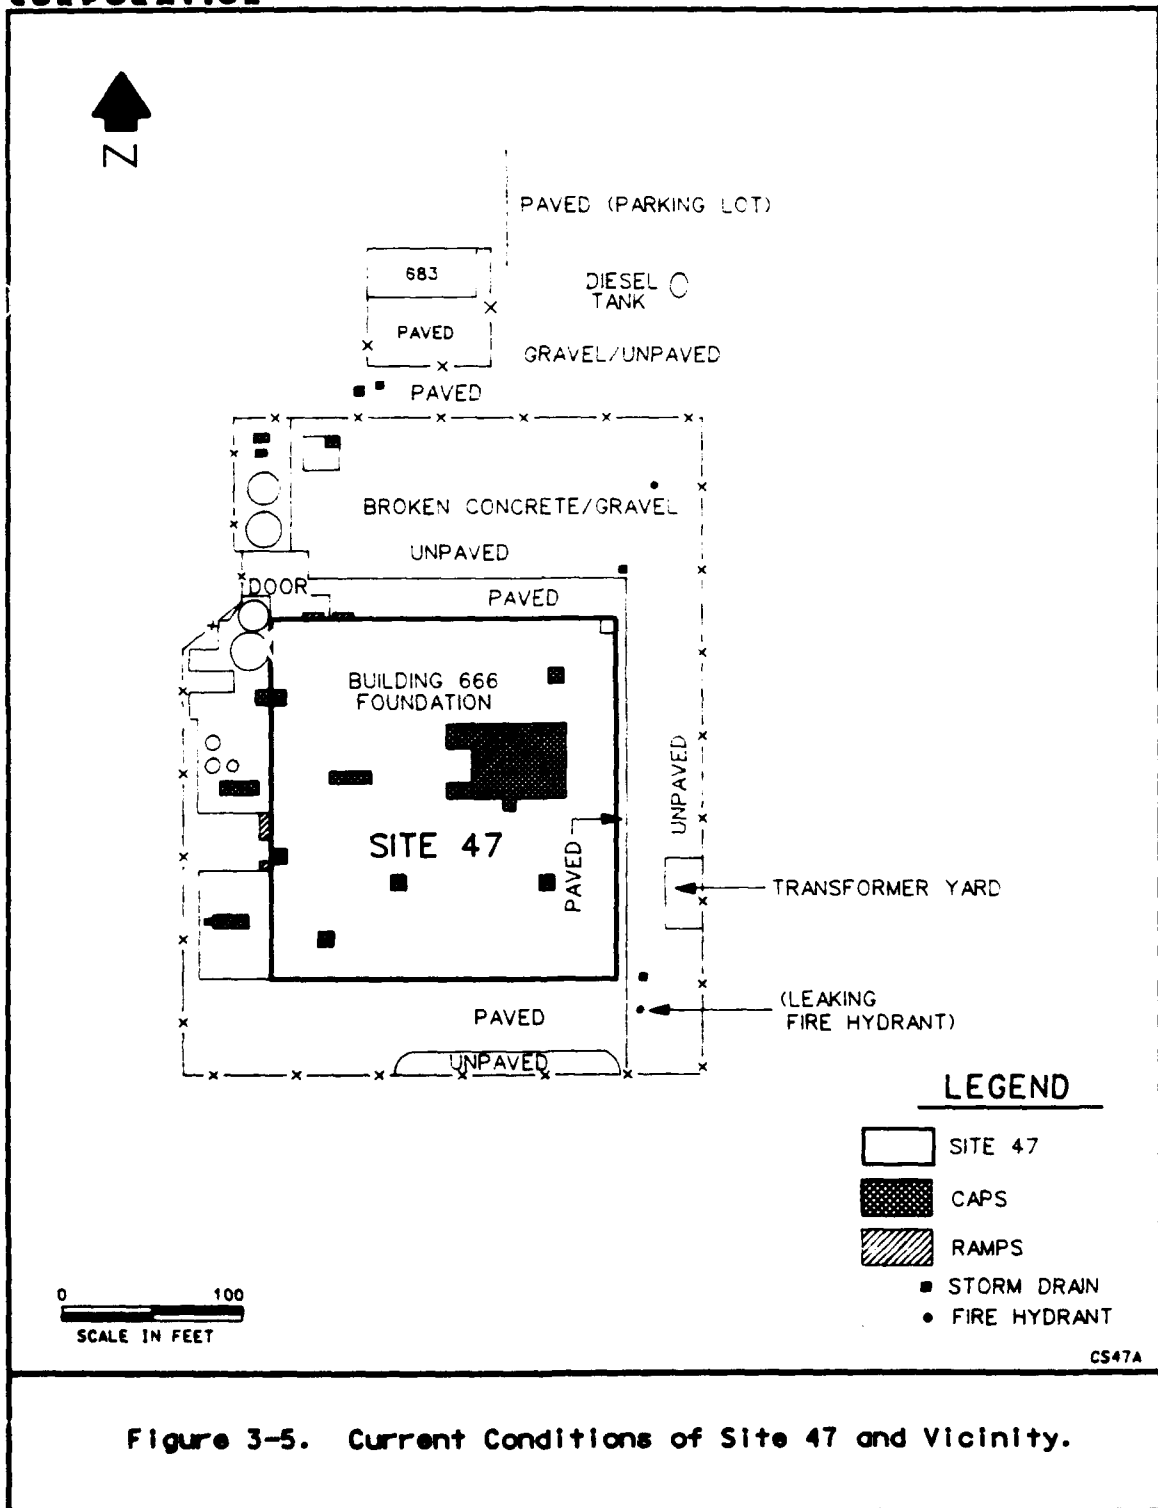
Figure 3-5. Current Conditions of Site 47 and Vicinity.

Building 666 was dismantled in 1988. The purpose of the dismantlement was described in the statement of work as follows:

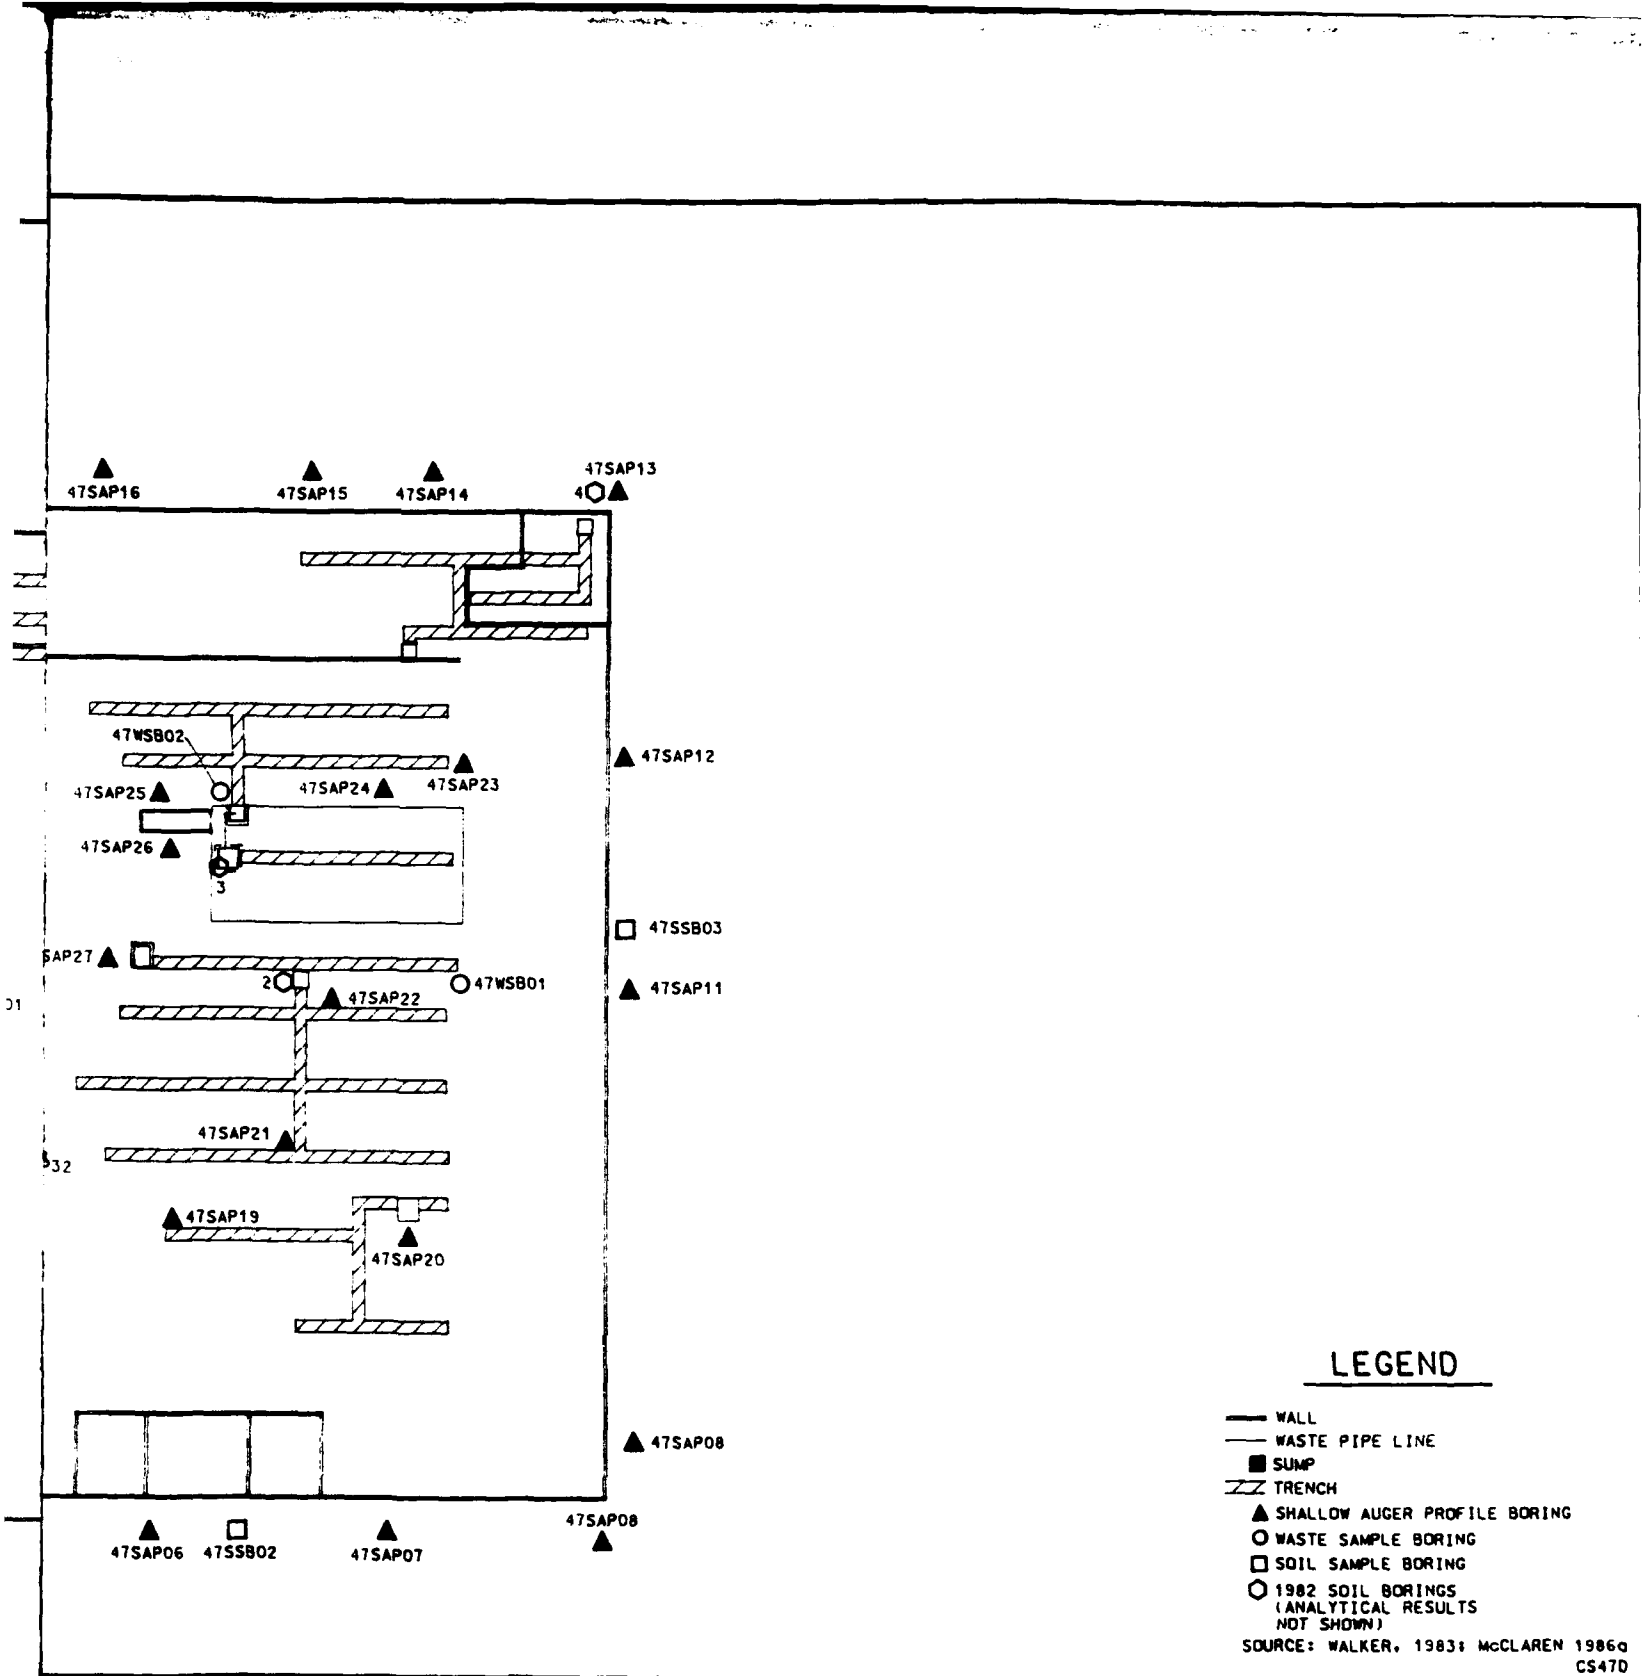
Figure 4-6. Boring Locations for Site 47.

This section presents the physical characterization of the soil, analytical results of soil samples, and evaluates of the adequacy of the soil characterization. Two separate soil investigations have been performed at Site 47: Thomas J. Walker's investigation in 1982 and the McLaren Environmental Engineering, Inc., (McLaren) investigation in 1985 (Walker, 1983; McLaren, 1986a). Results presented in this section are from data obtained from these investigations. Figure 4-6 shows the location of all borings drilled at Site 47.
